INSPECTION AND EVALUATION OF DAM AFTER SERIAL EARTHQUAKE

Suhardi¹, Heri Sulistiyono² & Hartana³

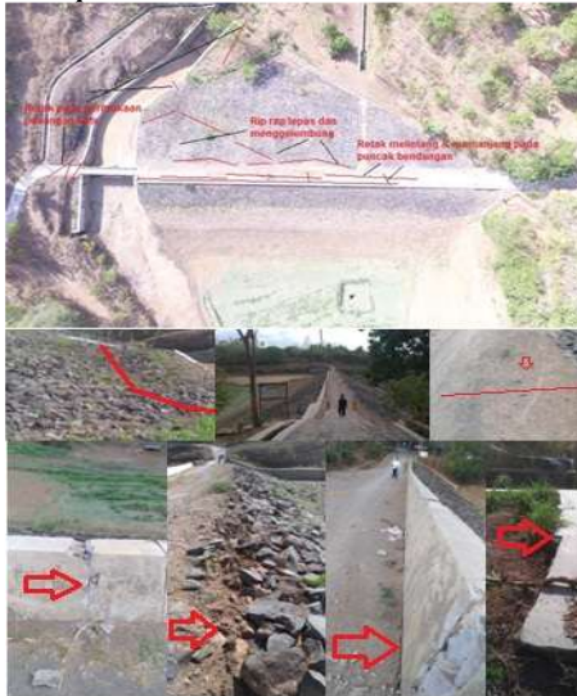
Figure 5 the Gegurik dam after the earthquake

The Gegurik Dam is located 10-20 km from the epicenter of the first strong earthquake on 29 July 2018 with a magnitude of Mw 6.4. During the earthquake, the Gegurik dam was empty. Because water collected during the previous rainy season has been used for irrigation supply. After being rocked by 3 consecutive strong earthquakes on July 29, August 5 and August 9 with the magnitudes of Mw 6.4, Mw 7.0, and Mw 6.2; longitudinal cracks and transverse were found on the top of the Gegurik Dam with widths ranges from 3 to 5 mm, the parapet was stretched around 3 mm, and the rip-rap was torn. Figure 5 shows the Gegurik dam after the earthquake.

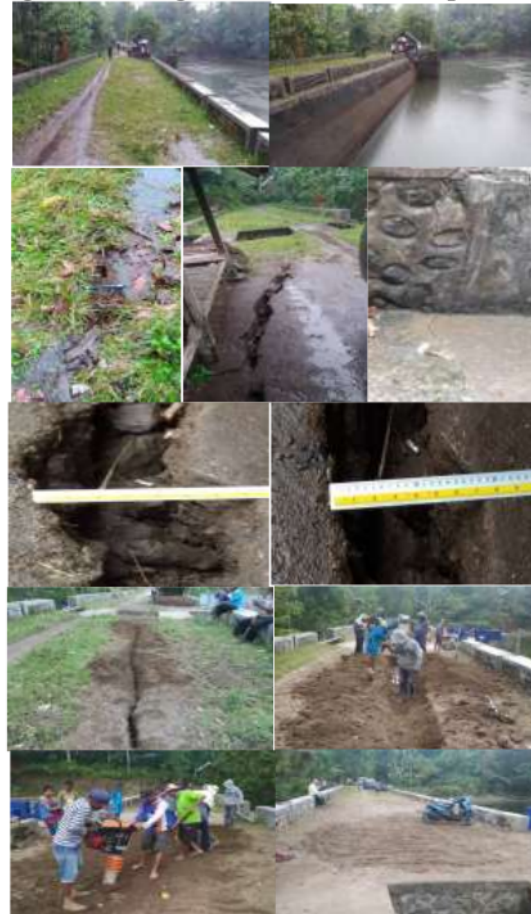
Figure 6 the Jago dam after the earthquake

Jago Dam is located 30-40 km from the epicenter of the first strong earthquake on July 29, 2018. During the earthquake, the Jago dam is full of water. The results of inspections carried out on August 16, 2018 showed that there were some cracks on the top of the dam with widths range from 10 to 170 mm. Uncontrolled seepage occurred on the downstream of embankment. Figure 6 shows photographs of the Jago dam after the earthquake.

- a. Jago Dam with a height of 15 meters is located in the range of 30-40 km from the epicenter. This dam experienced a crack of 17 cm until the third earthquake on August 5, 2018, this crack enlarged to 20 cm due to a large earthquake on August 19, 2018.
- b. Pandanduri Dam, 42 meters high, is located at a distance of 40-50 km from the epicenter. This dam did not experience a crack at the top of the dam, but it has not been measured whether there was a decrease in the dam's peak during the inspection.

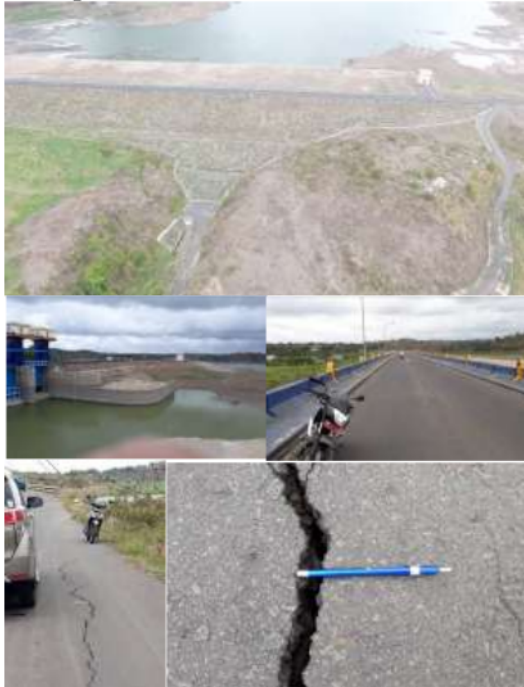
Figure 7 the Pandanduri dam after the earthquake

Pandanduri Dam is located 40-50 km from the epicenter of the first strong earthquake. During the earthquake, the Pandanduri dam is filled of water at a low water level. The results of inspections conducted on August 16, 2018 indicate that there was a longitudinal crack on the access road. The road is on the saddle dam of the Pandanduri dam. Figure 7 shows the Pandanduri dam after being shaken by the earthquake. Figure 8 shows the inspection on hydromechanics of Pandanduri Dam. Figure 9 shows pore water pressure in the core zone of Pandan Duri dam at station 650. Figure 10 shows settlements in the Pandanduri core zone at each layer's elevation at station 660 and reservoir water level. Figure 11 show the seepage discharge read in the V-notch gauge.

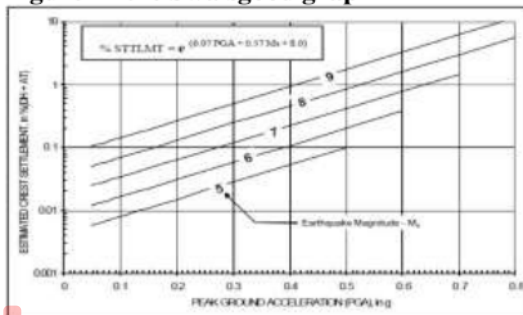
Figure 12 the Swaisgood graph

Figure 12 shows the graph of the relationship between the estimated amount of settlement at the peak of the dam with the PGA value at the dam that was rocked by the earthquake. Based on the graph, the estimation of settlements is shown below

$$\begin{aligned} \text{Settlement of Jago Dam} &= (0.015 + 0.025 + 0.017 + 0.021)\% \times \text{the height of the Dam} \\ &= 0.078 \% \times \text{the height of Jago Dam} \\ &= 0.078 \% \times 1,500 \text{ cm} \\ &= 1.170 \text{ cm} \end{aligned}$$

$$\begin{aligned} \text{Settlement of Pandanduri Dam} &= (0.015 + 0.025 + 0.017 + 0.021)\% \times \text{the height of the Dam} \\ &= 0.078 \% \times \text{the height of the Dam} \\ &= 0.078 \% \times 4,200 \text{ cm} \\ &= 3.276 \text{ cm} \end{aligned}$$

- f. The height of dam has to be refixed.
