# Study of Road Surface Damage due to Rainwater Puddles using the Pavement Condition Index

### Study of Road Surface Damage due to Rainwater Puddles using the Pavement Condition Index

Taufikurrahman <sup>1</sup>, I Dewa Made Alit Karyawan <sup>1</sup>, I Wayan Yasa <sup>1</sup>

DOI: 10.22178/pos.84-8

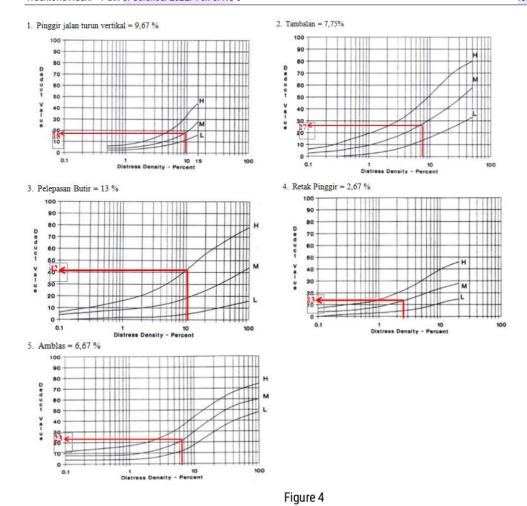
Deduct value is the reduction value for each type of damage obtained from the graph. Deduct Value (DV) STA 0+100 to 0+150 on Jalan Swasembada Kekalik can be seen in Figure 4.

Finding the maximum corrected subtraction (CDV). The CDV value in the STA segment 0+100 to 0+150 on the Jalan Swasembada Kekalik section is q=5 (there are 5 DV values > 5), see Table 5 the CDV value = 65.
