Study of Road Surface Damage due to Rainwater Puddles using the Pavement Condition Index

Taufikurrahman¹, I Dewa Made Alit Karyawan¹, I Wayan Yasa¹

¹ *University of Mataram*

Abstract. Damage to the road surface will cause many losses that users can feel directly. One of the factors that influence the damage is waterlogging. In Mataram City, several roads experience inundation and water runoff when it rains, such as Jalan Swasembada Kekalik and Jalan Kesra Raya Perumnas. The impact on road construction is a change in the shape of the road surface layer, which causes road service performance to decline. So, it needs to be analyzed to determine the damage to the pavement structure in several segments, both flooded and not. The method used to carry out road damage analysis is the method (Pavement Condition Index) PCI. Surveying road conditions in the field collected data. The PCI value is obtained after calculating the parameters, namely: density, deduct value (DV), total deduct value (TDV), and corrected deduct value (CDV). The results showed that the types and average values of damage to Jalan Swasembada Kekalik were: subsidence (6.22%), edge cracks (3.22%), vertical downhill road

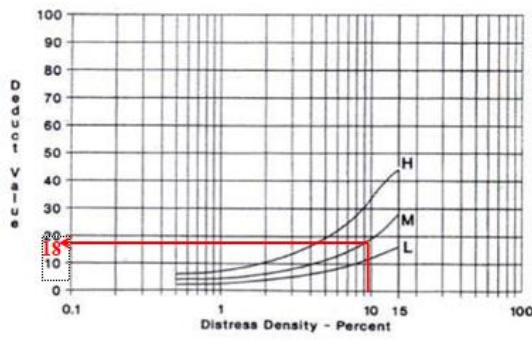
1. Pinggir jalan turun vertikal = 9,67 %

Side of the road down vertically =
 $29/(6 \times 50) \times 100 = 9.67\%$

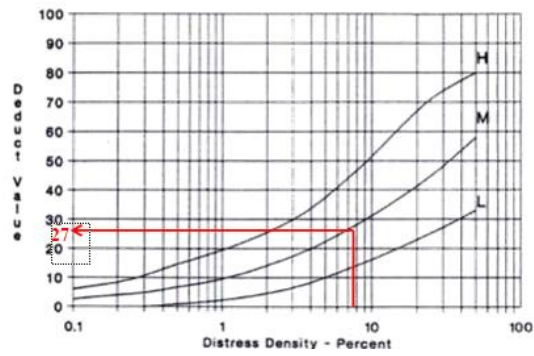
2. Tambalan = 7,75%

Patches = $22.5/(6 \times 50) \times 100 = 7.75\%$

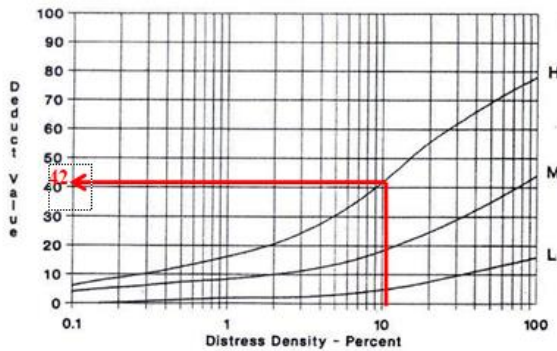
3. Pelepasan Butir = 13 %

Grain release = $39/(6 \times 50) \times 100 = 13\%$

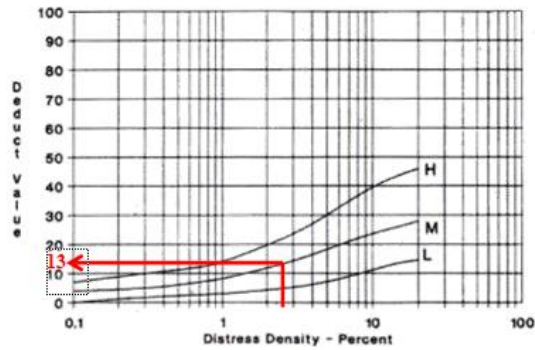
4. Retak Pinggir = 2,67 %

Edge Crack = $8/(6 \times 50) \times 100 = 2.67\%$

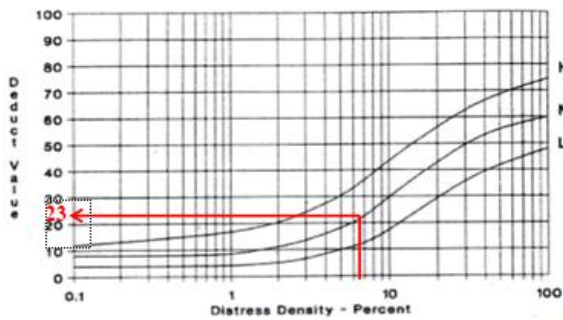
5. Amblas = 6,67 %

Sink = $20/(6 \times 50) \times 100 = 6.67\%$
