The Audit and Assessment of Building Structural Strength (Case Study of Mataram Islamic State University Rectorate Building)

Rijali Amin*, Suryawan Murtiadi, Akmaluddin

Master of Civil Engineering, Faculty of Engineering, Mataram University, Indonesia

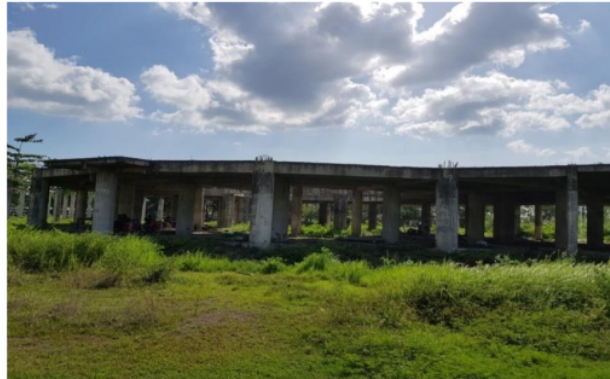
Figure 1 Existing Condition of *Mataram Islamic State University*

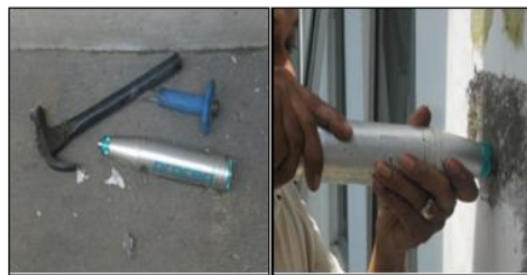
NDT (Non Destructive Test) on concrete surfaces have been done using hammer test. The aim of the test is to get the quality and compressive strength of the existing concrete. The positions of hammer test equipment and The *Schmidt Rebound Hammer Test* tool are presented in Table 1 and Figure 2, respectively.

Figure 2 The *Schmidt Rebound Hammer Test* tool

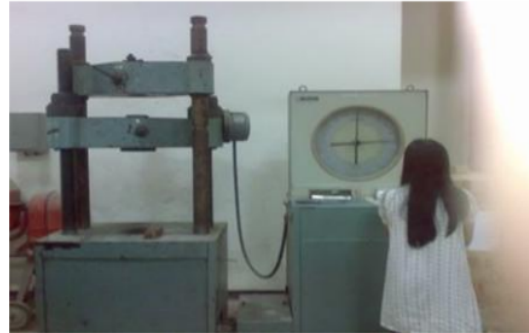
which was taken from the existing structure. The steel with the tensile yield strength of 400 MPa was used. The tool used for test in Laboratory of building construction material of the Faculty of Technical Engineering of Mataram University was UTM (*Universal Testing Machine*) of Shidmazu brand. The UTM tool can be seen in Figure 3.

Figure 3 UTM (*Universal Testing Machine*) Tool

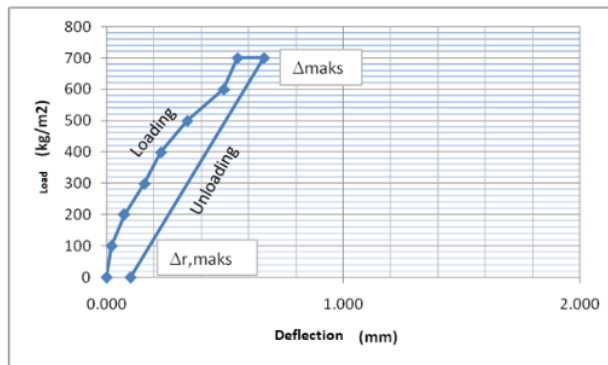
And the correlation between load and deflection on beam is presented on Figure 5

Figure 5 Correlation between load and deflection of the beam 300/700 (dial 2)

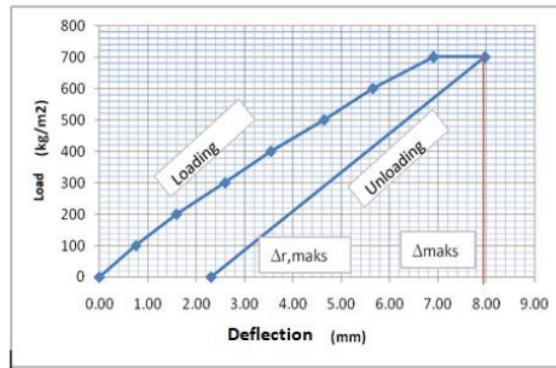
From the deflection measurement during the load test on beam 200/500, it was obtained a curve which showed the correlation between the amount of loading and unloading with deflection on

structure beam. The curve of correlation between load and deflection on beam is presented in Figure 6.

Figure 6 The correlation between load and deflection of beam 200/500

For beam with size, width : b= 200 mm and height : h = 500 mm, with span length Lt = 7650 mm, based on the regulation in Chapter 22 *SNI 03-2847-2002*, the amount of maximum deflection and maximum permanent deflection allowed was: maximum deflection : $\Delta = Lt^2 / (20000.h) = (7650)^2 / (20000.500) = 5.85$ mm, maximum permanent deflection: $\Delta r = \Delta / 4 = (5.85) / 4 = 1.463$ mm. Because the amount of maximum deflection (Δ_{max}) measured on beam 200/500 (table 7. $> \Delta =$

5.85 mm and the amount of permanent deflection ($\Delta r, max$) $> \Delta r = 1.463$ mm, it could be concluded that the structure beam did not meet the requirements.

3. Construction of the stairs should be changed with construction of steel WF, since there are no adequate reinforcing bars to connect the stairs reinforcement. Based on the loading test, beam with dimension of 200/500 does not meet the qualification. Therefore, it needs additional reinforcement where the reinforcement can be fixed with method of jacketing. The ideal is that the dimension of the beam is 300/600 or by decreasing the load on the second floor by using light material as partition wall.
