# Study on Robustness of Rebound Hammer and Ultrasonic Pulse Velocity Measurement in Several Concrete Damage Levels

Ni Nyoman Kencanawati, Akmaluddin, Rima Marlitasari, Gazi Paedullah

Civil Engineering Department Mataram University, Jl. Majapahit No 62 Mataram Indonesia

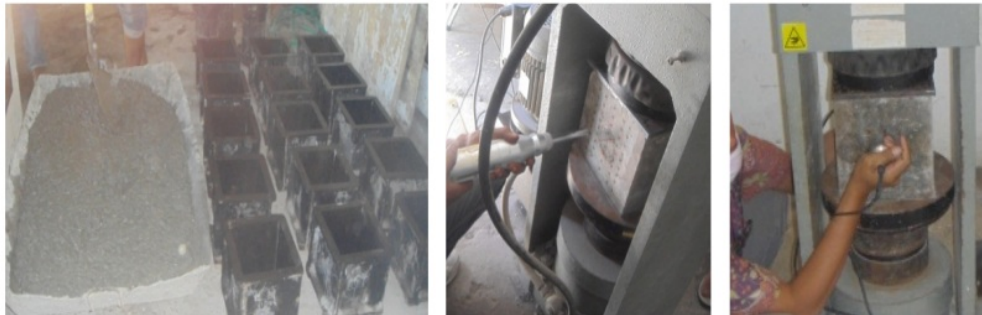
Figure 1. Concrete casting and testing

The 28-day compressive strength testing using the compression testing machine provided the actual compressive strength on each concrete strength group. The damage was determined by applying a load of 30%, 50%, and 80% of the maximum compressive strength. Next, each concrete strength group with each level of damage was tested using a hammer and UPV. The crack-free surface was chosen when measuring the concrete using NDT followed by making the concrete surface smooth.

Furthermore, the hammer test was performed on nine measurement points of each side of the concrete cube. Whereas the UPV test was carried out using the direct method where the transmitter sensor was placed in the center of the cube side and the receiver sensor is placed at the center of the cube on the opposite side. Table 2 and Figure 1 present the concrete casting and testing method. The method of measurement is according to Indonesian Standard [14] and ASTM [15].

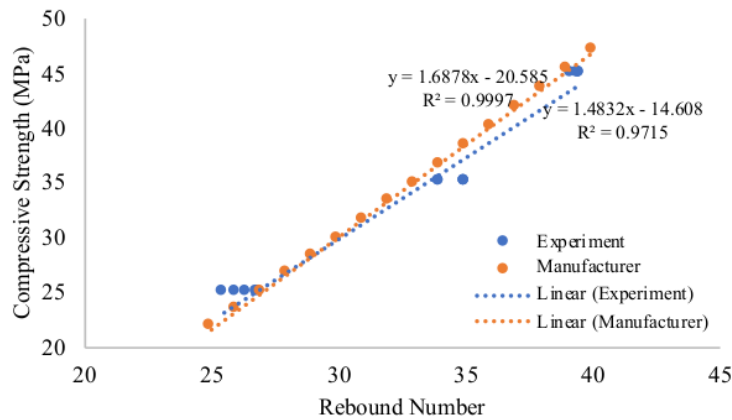
According to the experimental results, the relationship between the rebound number and compressive strength is linear as presented in Figure 2. This curve agrees with the calibration curve produced by many researchers [1], [2], [10], [16]. The larger value of RN gives a higher value of compressive strength. The consistent results show the robustness of hammer reading. The almost similar calibration curve is provided by Schmidt Hammer manufacturing company. The calibration curves of the manufacturing company are also presented in Figure 2 as a comparison. In the beginning when there is a relatively low rebound number the experimental curve hits the manufacturer curve. However, after passing the rebound number of 33 the experimental calibration curve provides a more conservative value. If a regression is developed as illustrated in Figure 3, three regions are clearly classified, namely, RN is smaller than 27, the calibration curve of the company curve is more conservative, between 27-33 both curves give the same calibration value and above 33 shows a conservative value for the experimental results.

Figure 2. Correlation between RN and compressive strength

Reading of RN and UPV was conducted in advance prior to the concrete applied to a maximum compression load for determining the compressive strength. Thus, the relation between the reading of either RN or UPV and actual compressive strength can be shaping as illustrated in Figure 2. The values presented in Figure 2 are the average readings of RN and UPV on each concrete strength. In addition, the correlation between RN and predicted compressive strength from the manufacturer is also provided as the comparison. Meanwhile, the correlation between UPV and compressive strength from other researcher is used as comparison since it is not provided by the manufacturer.

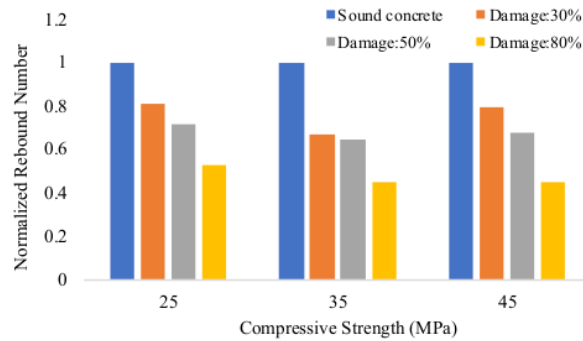
Damage has obviously influenced the reading of RN as presented in Figure 4. It shows the normalized RN in which RN in sound concrete having a value of 1. The RN has decreased in line with the increase in the level of concrete damage. The RN in concrete with a damage level of 30% drops slightly to around

20%. This value decreases repeatedly at the level of damage of 50% which is 30 to 40%. And at an 80% damage level, the RN is found only half of the sound concrete RN value.

Figure 4. Effect of damage to RN

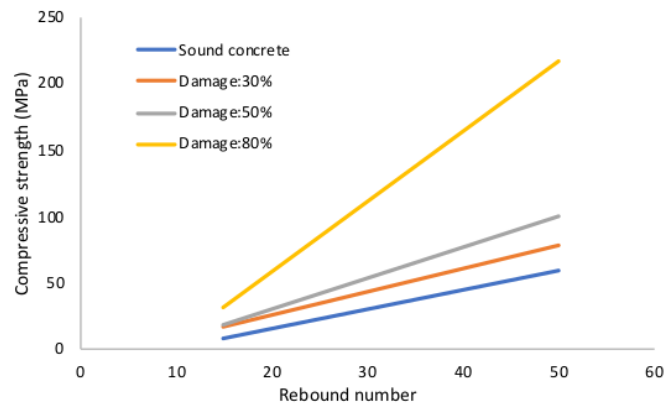
The calibration curve of the hammer test reading at each level of concrete damage is shown in Figure 5. A calibration curve for intact concrete is also provided as a comparison. The calibration curve is developed based on the regression of RN-compressive strength on each concrete damage condition. The higher level of concrete damage shows the greater gradient of the curve. Concrete that has been damaged up to 80% produces a slope of 3.6 times the gradient of the calibration curve on sound concrete. The greater slope of the curve raises the compressive strength conversion value. For example, for the RN value of 25, for damaged concrete calibration curves gains a very large compressive strength value exceeds the actual compressive strength. In this case, it is supposed that the reading of a hammer test indicates less of robustness. This finding is similar to [11], [16] which concluded that the hammer test is not recommended for testing old concrete and even it is further suggested that it does not correlate the RN value with the existing concrete compressive strength because the results are not reliable.

Figure 5. Hammer test calibration curve for damaged concrete

- Ultrasonic provides better robustness for measuring damage concrete.
- Concrete that has been damaged up to 80% produces a slope of 3.6 times the gradient of the calibration curve on sound concrete during hammer measurement.
- UPV calibration curve is valid until velocity of 3500 m/s for damaged concrete.
- The huge growth of compressive strength exceeds the compressive strength of sound concrete is found on 50% damage concrete since it has the greatest exponential constant of the curve.

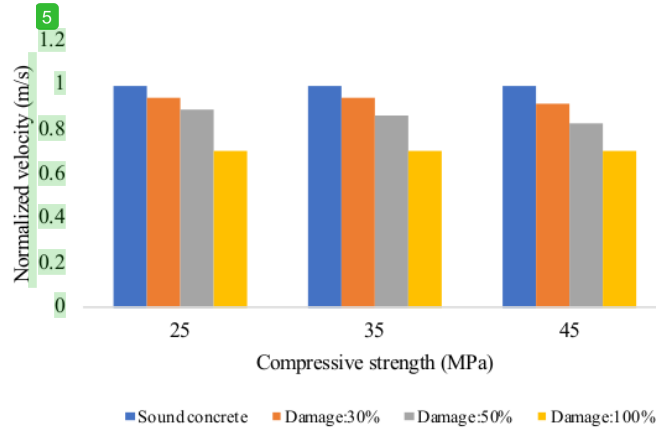
In case of UPV reading, similar to RN, concrete damage condition affects the velocity. More severe concrete damage produces smaller velocity. Other studies reveals the same finding as this research [1], [2], [5], [16]. More voids and cracks exist in damage concrete as the result the velocity decreases because

the wave need more time to propagate inside the concrete. Figure 6 presents the normalized velocity of each compressive strength for several damage level. The unity belongs to sound concrete velocity. In average, the velocity loss is proportional to damage level which are 7%, 13% and 29% decrease of velocity for damage level of 30%, 50%, and 80% respectively.

Figure 6. Effect of damage to UPV

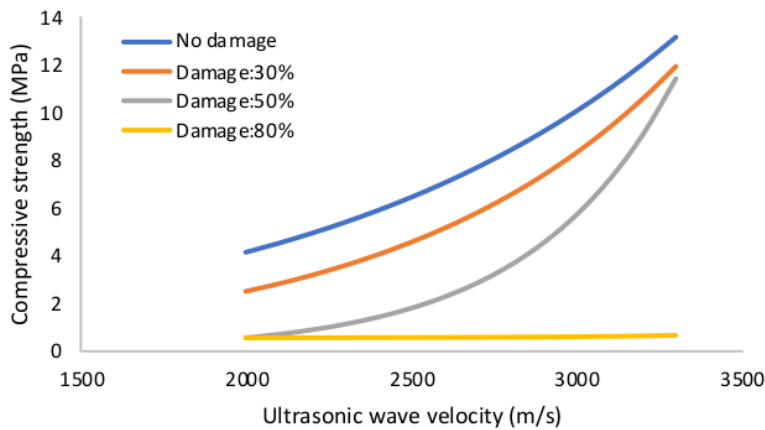
The calibration curve of UPV reading at each level of concrete damage is shown in Figure 7. A calibration curve for intact concrete is also provided as a comparison. The calibration curve is developed based on the regression of UPV-compressive strength on each concrete damage condition. UPV calibration curve show better robustness since the damage concrete produces a smaller velocity. However, the calibration curve is valid until velocity of 3500 m/s. The huge growth of compressive strength exceeds the compressive strength of sound concrete is found on 50% damage concrete since it has the greatest exponential constant of the curve.

Figure 7. UPV test calibration curve for damaged concrete
