The 2nd International Conference on Rehabilitation and Maintenance in Civil Engineering

Post-Construction Problems of Embung in Lombok Island and the Operation and Maintenance Works

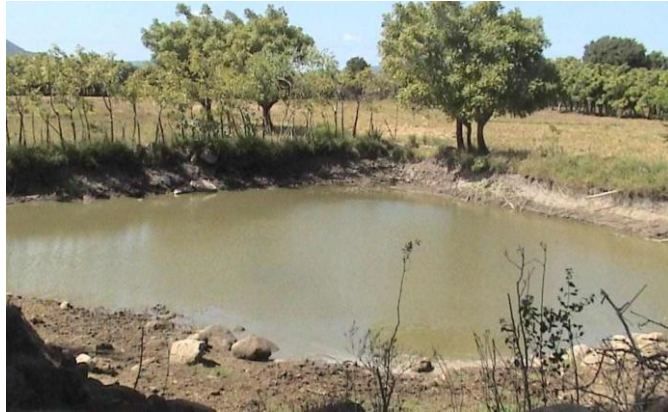
The construction of *embung rakyat* is fairly simple in the form of a small pond surrounded by hand compacted soils as its embankment with rectangular shape (see Figure 1). On top of the embankment, the owner plant trees and bamboos to prevent landslide or erosion caused by human or cattle. *Embung rakyat* is equipped with a simple intake using a perforated palm tree as a replacement of pipe (Marsudi et al,

Figure 1. A typical *embung rakyat* (Saadi et al, 2010)

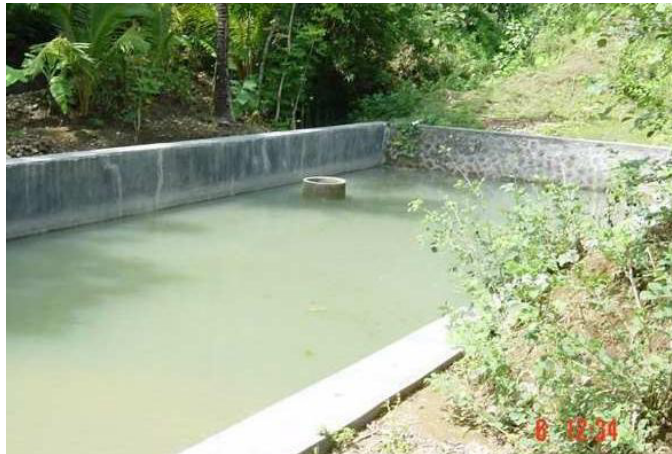
Figure 2. An *embung desa* with masonry structure as its embankment (Courtesy of BISDA NTB)

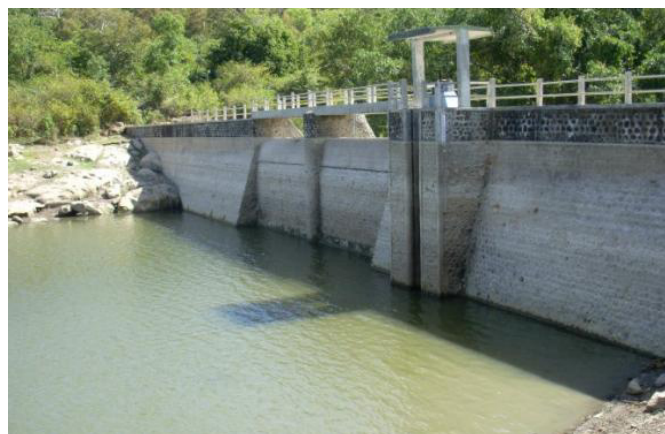
The construction of *embung pemerintah* can be of many types, depending upon how the available materials are utilized. It could be in the form of masonry or concrete dam (see Figure 3) or in the form of earthfill or rockfill dam. *Embung pemerintah* requires ancillary structures to enable it to operate safely and effectively. Spillway is important for the safe passage of flood whilst outlet work or intake is intended to fulfil the irrigation purpose. Other ancillary facilities are incorporated as necessary. In an *embung pemerintah* it is expected to see Open Standpipe Piezometers to measure the pore pressure, Seepage Chamber to measure seepage and Crest Settlement Points for measuring surface movement of embankment both in horizontal and vertical direction.

Figure 3. An *embung pemerintah* equipped with adequate intake and spillway (Courtesy of BWS NT I)

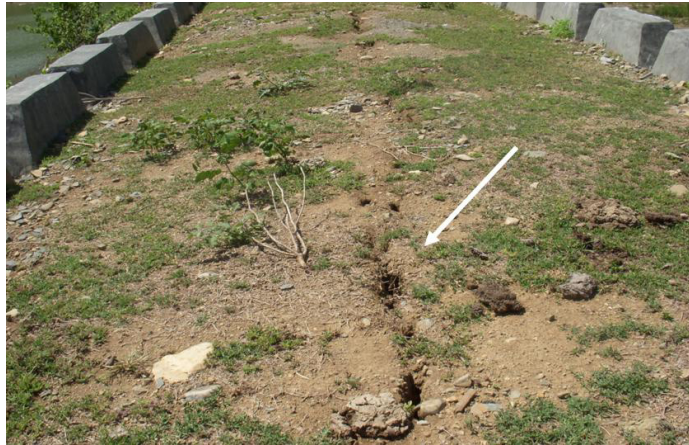
Visual inspections indicate that common problems found in the embankment of embung include uneven surface caused by lack of maintenance, differential settlement and poor quality of compaction. In many cases, this leads to the existence of crack along the embankment's crest (see Figure 4).

Figure 4. Cracks on top of the embankment (Courtesy of BWS NT I)

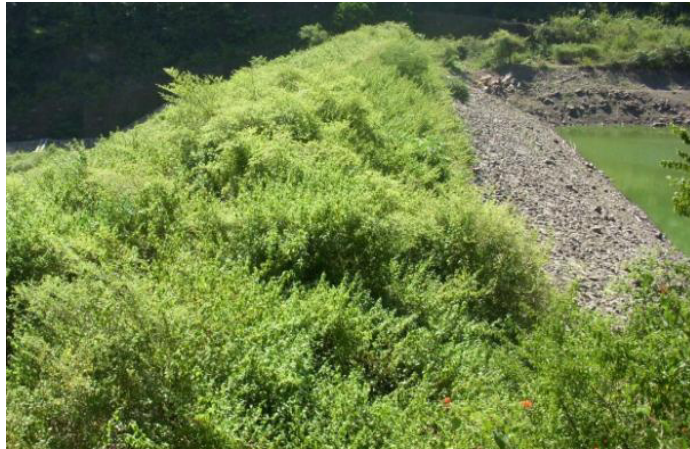
The spread of bushes and other undesirable vegetation on top of the embankment are often ignored by the Operation and Maintenance (O&M) personnel. Figure 5 shows an example of bad maintenance where the unwanted vegetations cover the crest and downstream slope of the embung. Many think that vegetative cover on the downstream slope of embankment can afford sufficient protection from the erosion caused by wind and rainfall runoff. Although there is a good example of using native grasses that have protected the downstream slope of a dam for decades, careful consideration must be taken into account when applying vegetative cover (USBR, 1987). The growth level of grass should be maintained, where fertilizer and uniform sprinkling of the seeded areas are regularly necessary. Most embung cannot provide sufficient water along the year so that in one way or another, this activity is not very simple to carry out and probably costly.

Figure 5. Undesirable vegetations cover the top and downstream slope of embung
(Courtesy of BWS NT I)

The existence of unwanted vegetation such as trees can displace the rock cover or riprap, forming a gap in between and the rock become more expose and less easier to move downward. Where the cost is not prohibitive, in arid regions such as in the southern part of Lombok protection by cobbles or rock is preferred than vegetative cover and should be used to provide sufficient protection.

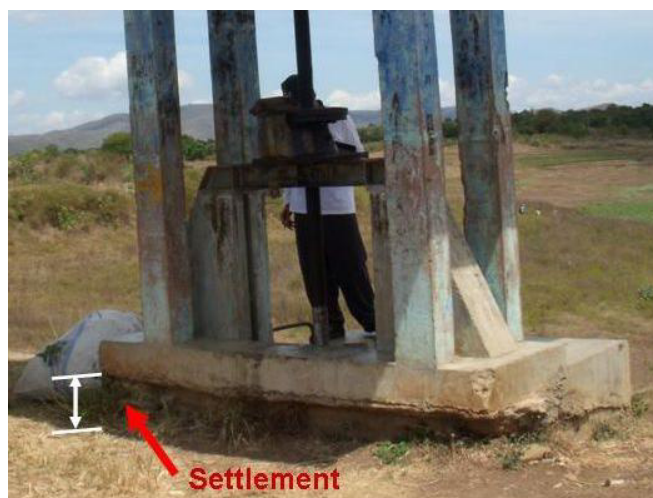
In many cases, illegal activities such as the collection of timber from nearby forest involving frequent movement of heavy vehicles and a large group of cattle, e.g buffalo, along the embung crest also contribute to the deformation and consolidation of the embankment. The existence of deformation and internal cracking leads to the settlement of embankment (see Figure 6). Settlement means loss of freeboard and the possibility of overtopping increases. Overtopping mechanism is of particular concern as this mechanism couple with internal erosion, being responsible for 60-70 % of serious incidents and failures of the embankment (Novak et al, 1996).

Figure 6. A noticeable settlement of embankment exists around the intake gate
(Courtesy of BWS NT I)

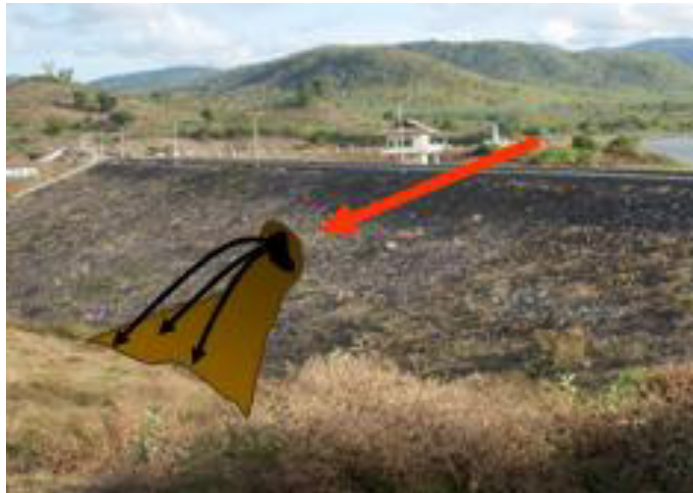
Figure 7. Seepage with mud flow accelerates mass failure (Courtesy of BWS NT I)

Seepage and leakage are also the common problem found in embung construction. Seepage occurs in an embankment (see Figure 7) whereas leakage occurs in masonry structure such as spillway (Figure 8). Seepage within embankment is particularly important to observe. Brown colour indicates that flow contain mud or embankment material. Continuous occurrence will result in mass failure.

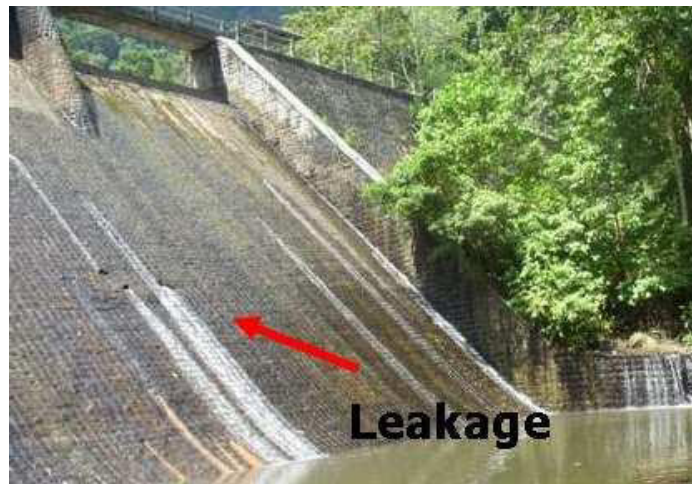
Figure 8. Leakage underneath spillway crest (Courtesy of BWS NT I)

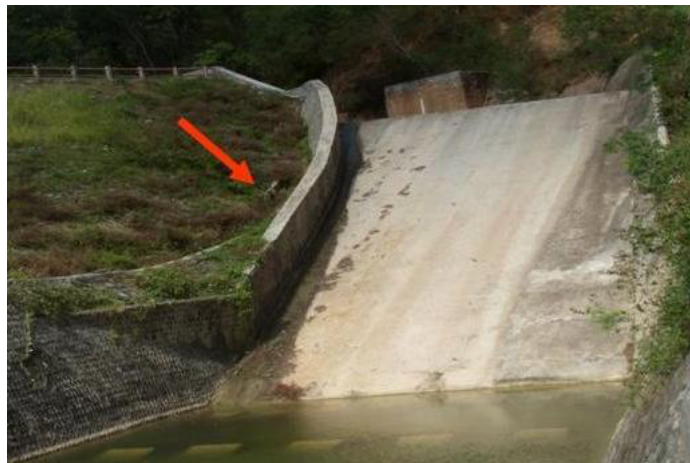
There are conditions where seepages and leakages take place at joint such those along the conduit and other types of outlet works (Figure 9) and between embankment and the wing wall of spillway (Figures 10 and 11). Continuous section of conduit is

In embung case, leakage between embankment and masonry or concrete structure is normally occurs as a result of different settlement and the existence of other factor such as earthquake. Therefore, sufficient flexibility should be considered to tolerate small settlement as well as the amount of steel reinforcing which should meet the generally accepted requirement.

Figure 10. Leakage between embankment and spillway (Courtesy of BWS NT I)

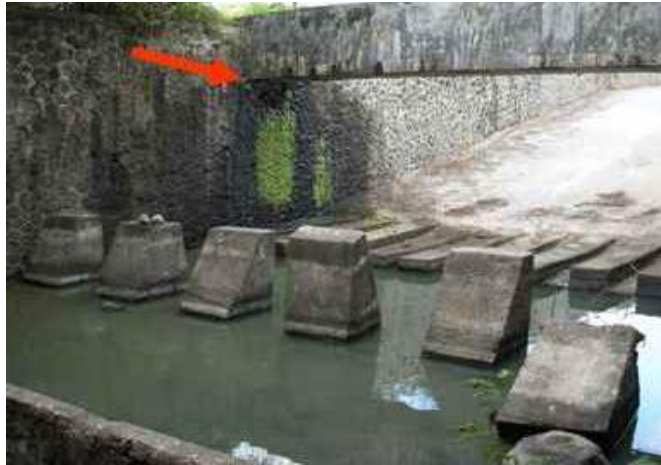
Figure 11. Leakage at the vertical wing wall of stilling basin (Courtesy of BWS NT I)

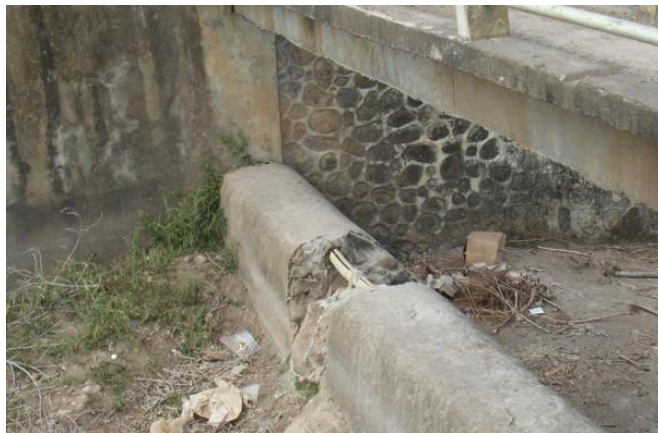
Other problem face by embung is the decrease in the level of service such as damages to the spillway crest (Figure 12), malfunction of outlet work due to improper installation of valve (Figure 13) and disintegration of concrete (Figure 14).

Figure 12. Damages to the spillway crest (Courtesy of BWS NT I)

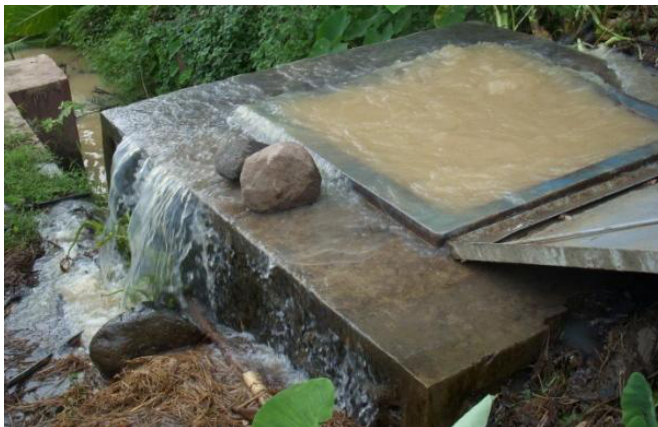
Figure 13. Improper installation of outlet valve (Courtesy of BWS NT I)

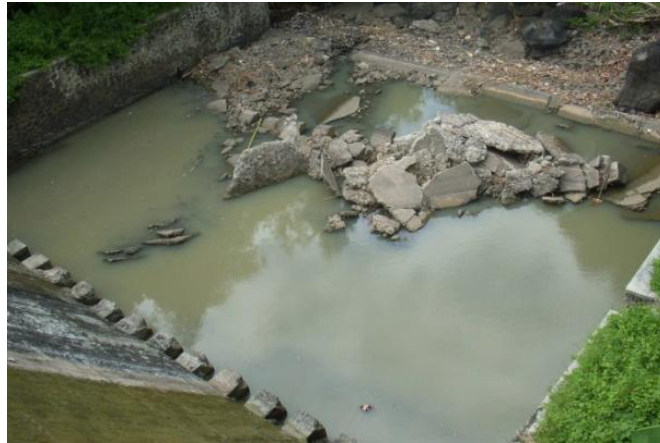
Figure 14. Disintegration of concrete at stilling basin (Courtesy of BWS NT I)

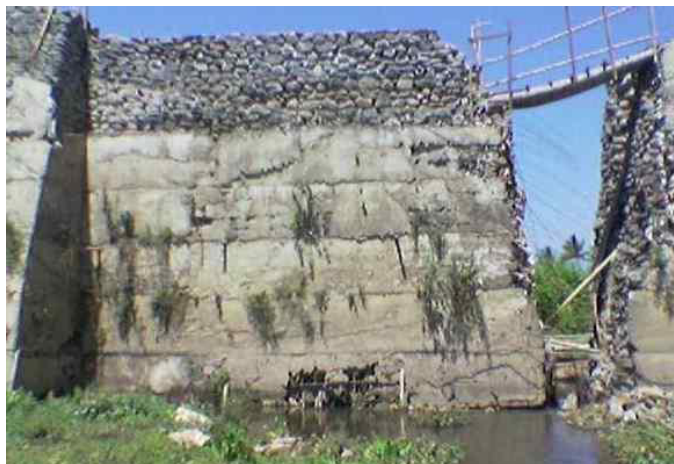
The construction of embung often found to be different than the original design. This inconsistency caused by the temptation to increase the capacity and the level of service. The easiest way is to raise the embankment without due consideration such as the relation of the resulting increased pressures to the limitations of the initial design. In the case of *embung rakyat*, such action may not have dangerous consequences but for a bigger construction of *embung desa* and *embung pemerintah*, structural modification should be made with approval of a qualified engineer, preferably the designer (USBR, 1987). Figure 15 shows an attempt to raise the height of embankment that leads to the failure of embung.

Figure 15. Additional height with different materials (Courtesy of BWS NT I)
