# Grouting performance of the Pandan Duri dam shacked by Lombok earthquake 2018

*Didi S. Agustawijaya*<sup>1\*</sup>, *Muji Wahyudi*<sup>1</sup>, *I Wayan Yasa*<sup>1</sup>, *Keke F. Ashari*<sup>1</sup>, and *Ausa R. Agustawijaya*<sup>2</sup>

**Abstract.** The Pandan Duri dam has an important role in water supply in the East Lombok District. Unfortunately, Lombok Island is located in a relatively high seismic risk area, as earthquakes occurred in 2018 have ruined almost one third of the island and destroyed thousands of buildings. The Pandan Duri dam is one of many infrastructures shacked by the earthquake. Modelling the dam shows that the grouting installation of the dam has supported the dam after the earthquake. The factor of safety (FoS) of the dam was still 1.76 after the earthquake for the flood water level conditions; but, the displacements could be significant to the stability of the dam, as the dam might displace up to 1.64 m. Although, the current grouting support system might provide the stability to the dam during earthquake events, the dam will certainly require further stability enhancement and close monitoring for possible similar events in the future.

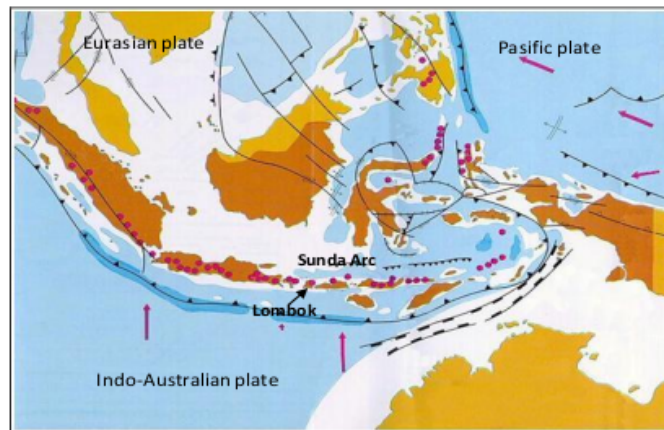
**Fig. 2.** Tectonic pattern of Indonesia [2, 3].

The Pandan Duri Dam is located in the East Lombok District of the West Nusa Tenggara Province, Indonesia (Fig. 1), and it has been one of many water infrastructures in Lombok Island [1]. Unfortunately, Lombok Island is a part of the most active seismic area in Indonesia, since three tectonic plates collide one to the others: Eurasia, Indo-Australia and Pacific (Fig. 2).

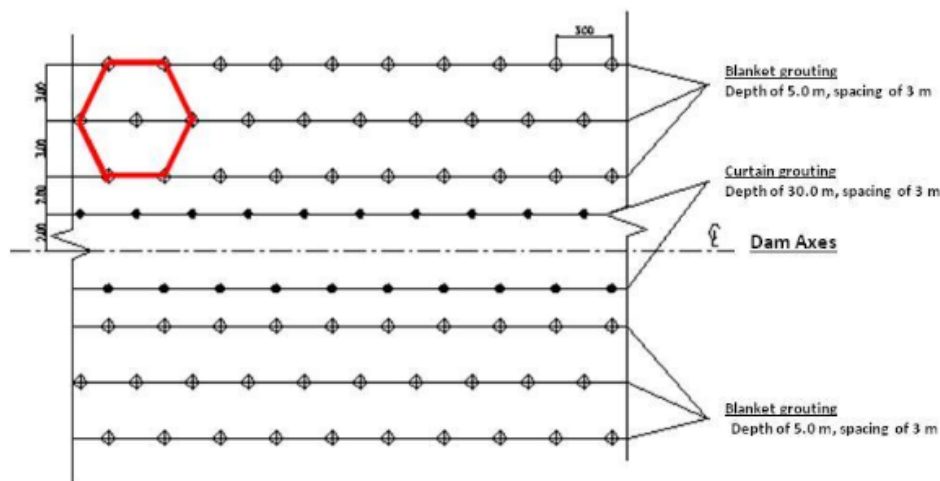
**Fig. 4.** Grouting installation of trapezoidal pattern [7].

The dam was supported by a grouting support system in a hexagonal pattern (Fig. 4). The main purpose of grouting is to reduce permeability, but it could also increases shear strength, reduces compressibility, and reduces internal erosion on foundations. The installations might add shear strength to the base of  $15 \text{ kg/cm}^2$ , so these were also intended to increase the stability of the dam shacked by earthquakes. Since the tectonic instability might be very much possibly to occur in Lombok Island [19, 19].

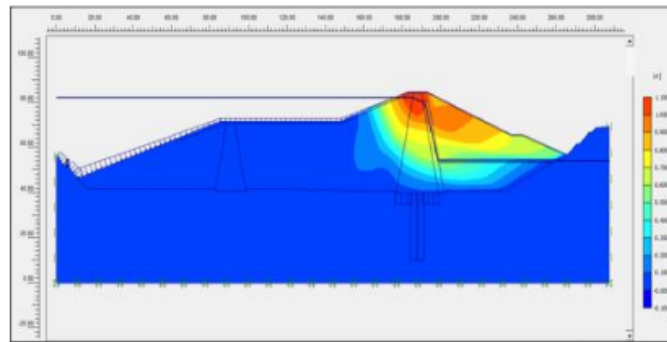
**Fig. 5.** The LWL model after earthquake events.

The elevation of the LWL was +264.0 m above the mean sea level (MSL), or 34 m above the dam base, while all dimensions of the dam were as stated earlier in the dam design. Numerical analysis shows that the FoS reduced significantly after earthquakes (Fig. 5), although the index was still 1.77, which was still in the range of stable conditions over 1.5.

However, the displacement could play an important role in the stability of the dam. The numerical analysis shows that the displacements of 8.9 cm might occur after the earthquake events. This displacement should be fine for the stability of the dam.

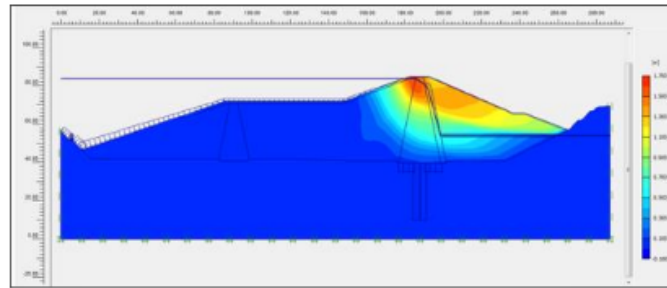
**Fig. 6.** The FLW model after earthquake events.

The elevation of flood water level (FWL) was +282.75 m above the MSL, or 1.25 m below the crest of the dam. The FWL model after the earthquake events shows that the FoS slightly reduced from the LWL conditions to be 1.76 (Fig. 6). But, the displacements could be significant, in which the dam could displace down to 164 cm after the event. This could be significant for the stability of the dam.
