5th International Conference on Rehabilitation and Maintenance in Civil Engineering:
"Advanced Research and Technology for Rehabilitation and Maintenance in Civil Engineering"
Surakarta, Indonesia on 8-9 July 2021

Investigation of Polypropylene Fiber Reinforced Concrete After Elevated Temperature Using Color Quantification and Alkalinity Method

Ni Nyoman Kencanawati, Suryawan Murtiadi, and Zul Aida Nur

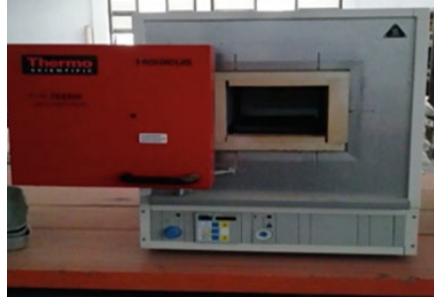
Fig. 1 Electric furnace

in Eq. 10. The furnace was an electric furnace, as shown in Fig. 1 The maximum temperature capacity was 1200 °C. The relation between time and temperature from the standard furnace test is given in Eq. 1 and Fig. 2.

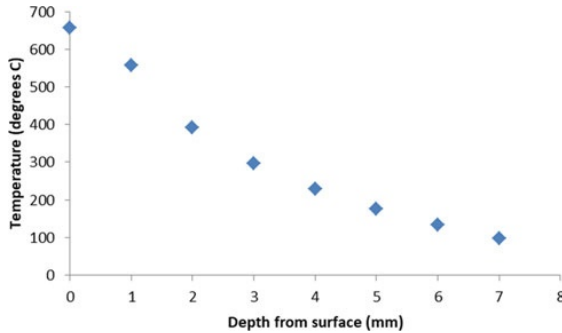
Fig. 3 Temperature rise in concrete for 700 °C exposed to fire

The temperature rise on the surface and some concrete depth using Wickstrom's method for a maximum temperature of 700 °C is given in Fig. 3. The temperature of the concrete surfaces approaches 657 °C; meanwhile, in the inner layer, the temperature is 82 °C. This temperature rise occurs in concrete, which has been exposed to the furnace test for one hour. The farther the position from the concrete surface causes a decrease in temperature.

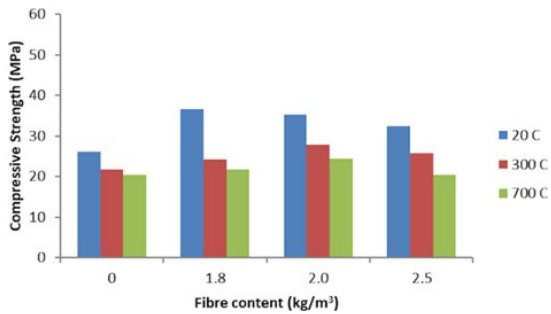
Fig. 4 Post-fire compressive strength of grade 25 MPa

At ambient temperatures (20 °C), it appears that concrete with the addition of polypropylene fibers of 1.8 kg/m³ reaches the highest compressive strength among other concrete with an additional proportion of other polypropylene fibers. This occurs either in the grade of 25 or 45 MPa. The addition of 1.8 kg/m³ polypropylene fiber has a compressive strength greater as much as 1.4 times compared to that of control concrete without fiber, both on concrete grade 25 and 45 MPa.

However, when the temperature increased to both 300 and 700 °C, the concrete containing 2 kg/m³ polypropylene fiber has the highest residual compressive strength

compared to concrete with other fiber content either in grade 25 or 45 MPa. For grade 25 MPa, concrete with a content of 2.0 kg/m^3 only decreased by 30% from its initial strength when being exposed to a fire of 700°C . For concrete with grade 45 MPa, it shows even better performance, which only decreases by 20%. Even at ambient temperatures, concrete with a fiber content of 1.8 kg/m^3 has the optimum strength, yet concrete with a fiber content of 2 kg/m^3 shows better performance when the temperature increases. When the temperature was high, the polypropylene fibers melted and provided more pores so that water subjected to vapor pressure due to high temperatures can pass and does not push the surrounding cement paste. This fiber content provides the pores needed by concrete when water vapour pressure occurs due to high temperature; therefore, cracks in the cement paste can be avoided. Thus, the concrete's performance with a fiber content of 2 kg/m^3 is better during the fire. Figure 4 and Fig. 5 present the concrete compressive strength at ambient and elevated temperature for concrete grade 25 MPa and 45 MPa respectively.

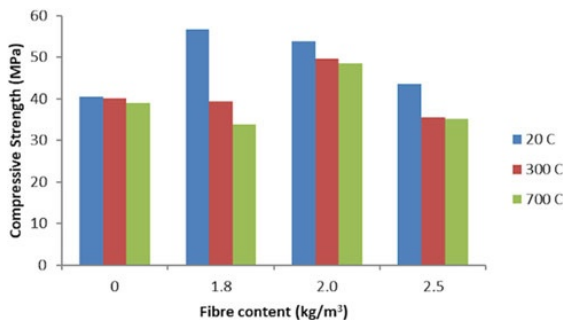
Fig. 5 Post-fire compressive strength of grade 45 MPa
