Post-Construction Problems of Embung

The 2nd International Conference on Rehabilitation and Maintenance in Civil Engineering

1
Post-Construction Problems of Embung in Lombok Island
and the Operation and Maintenance Works

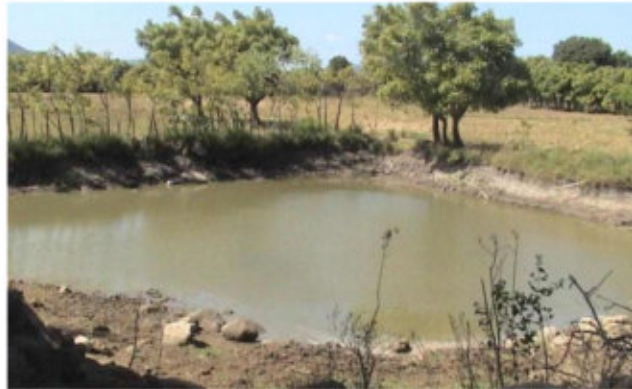
Figure 1. A typical *embung rakyat* (Saadi et al, 2010)

The construction of *embung rakyat* is fairly simple in the form of a small pond surrounded by hand compacted soils as its embankment with rectangular shape (see Figure 1). On top of the embankment, the owner plant trees and bamboos to prevent landslide or erosion caused by human or cattle. *Embung rakyat* is equipped with a simple intake using a perforated palm tree as a replacement of pipe (Marsudi et al,

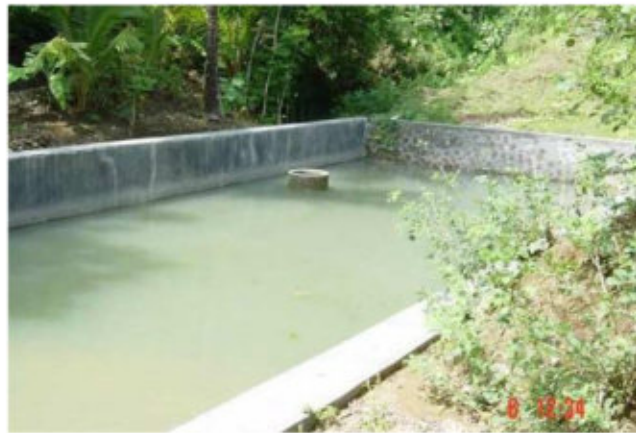
Figure 2. An *embung desa* with masonry structure as its embankment (Courtesy of BISDA NTB)

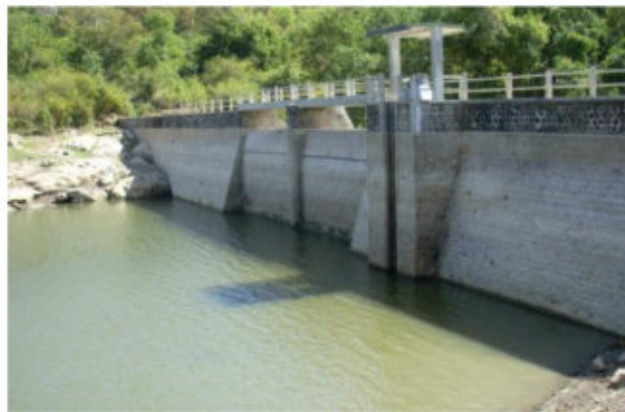
Figure 3. An *embung pemerintah* equipped with adequate intake and spillway
(Courtesy of BWS NT I)

The construction of *embung pemerintah* can be of many types, depending upon how the available materials are utilized. It could be in the form of masonry or concrete dam (see Figure 3) or in the form of earthfill or rockfill dam. *Embung pemerintah* requires ancillary structures to enable it to operate safely and effectively. Spillway is important for the safe passage of flood whilst outlet work or intake is intended to fulfil the irrigation purpose. Other ancillary facilities are incorporated as necessary. In an *embung pemerintah* it is expected to see Open Standpipe Piezometers to measure the pore pressure, Seepage Chamber to measure seepage and Crest Settlement Points for measuring surface movement of embankment both in horizontal and vertical direction.

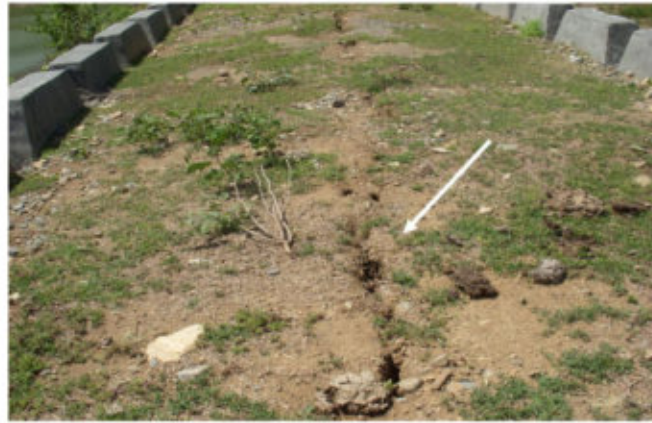
Visual inspections indicate that common problems found in the embankment of embung include uneven surface caused by lack of maintenance, differential settlement and poor quality of compaction. In many cases, this leads to the existence of crack along the embankment's crest (see Figure 4).

Figure 4. Cracks on top of the embankment (Courtesy of BWS NT I)

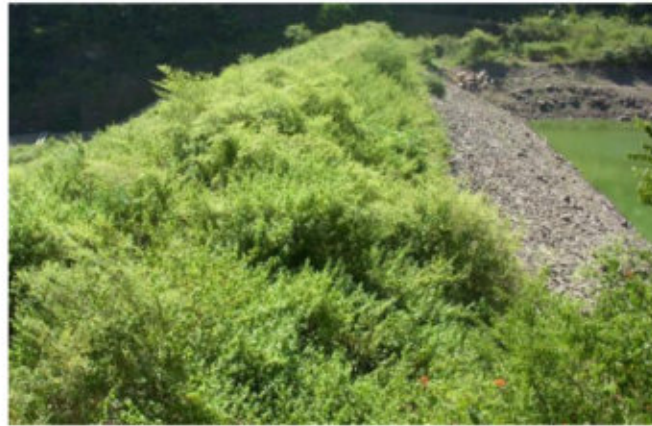
The spread of bushes and other undesirable vegetation on top of the embankment are often ignored by the Operation and Maintenance (O&M) personnel. Figure 5 shows an example of bad maintenance where the unwanted vegetations cover the crest and downstream slope of the embung. Many think that vegetative cover on the downstream slope of embankment can afford sufficient protection from the erosion caused by wind and rainfall runoff. Although there is a good example of using native grasses that have protected the downstream slope of a dam for decades, careful consideration must be taken into account when applying vegetative cover (USBR, 1987). The growth level of grass should be maintained, where fertilizer and uniform sprinkling of the seeded areas are regularly necessary. Most embung cannot provide sufficient water along the year so that in one way or another, this activity is not very simple to carry out and probably costly.

Figure 5. Undesirable vegetations cover the top and downstream slope of embung
(Courtesy of BWS NT I)

The existence of unwanted vegetation such as trees can displace the rock cover or riprap, forming a gap in between and the rock become more expose and less easier to move downward. Where the cost is not prohibitive, in arid regions such as in the southern part of Lombok protection by cobbles or rock is preferred than vegetative cover and should be used to provide sufficient protection.

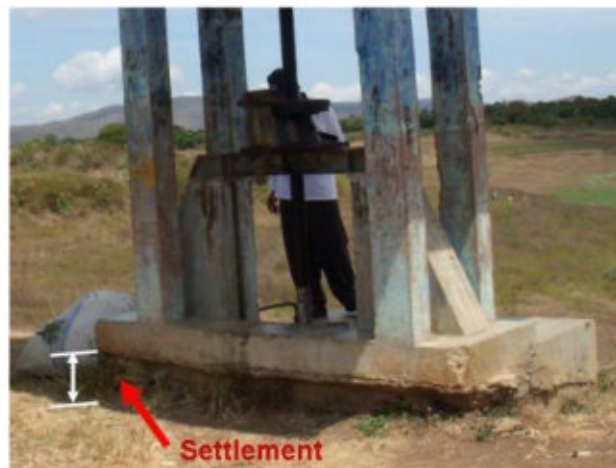
In many cases, illegal activities such as the collection of timber from nearby forest involving frequent movement of heavy vehicles and a large group of cattle, e.g buffalo, along the embung crest also contribute to the deformation and consolidation of the embankment. The existence of deformation and internal cracking leads to the settlement of embankment (see Figure 6). Settlement means loss of freeboard and the possibility of overtopping increases. Overtopping mechanism is of particular concern as this mechanism couple with internal erosion, being responsible for 60-70 % of serious incidents and failures of the embankment (Novak et al, 1996).

Figure 6. A noticeable settlement of embankment exists around the intake gate
(Courtesy of BWS NT I)

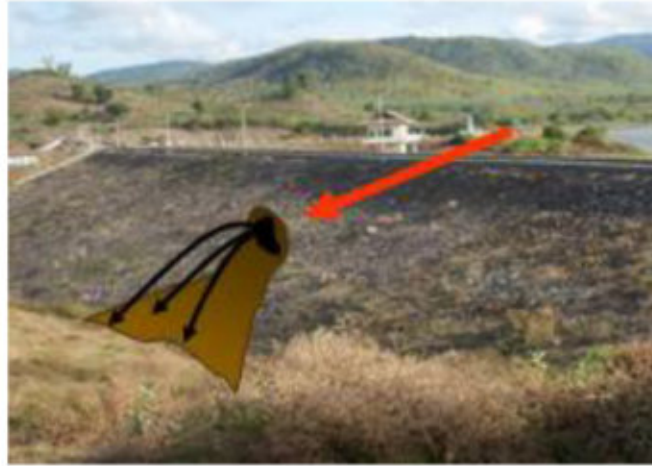
Figure 7. Seepage with mud flow accelerates mass failure (Courtesy of BWS NT I)

Seepage and leakage are also the common problem found in embung construction. Seepage occurs in an embankment (see Figure 7) whereas leakage occurs in masonry structure such as spillway (Figure 8). Seepage within embankment is particularly important to observe. Brown colour indicates that flow contain mud or embankment material. Continuous occurrence will result in mass failure.

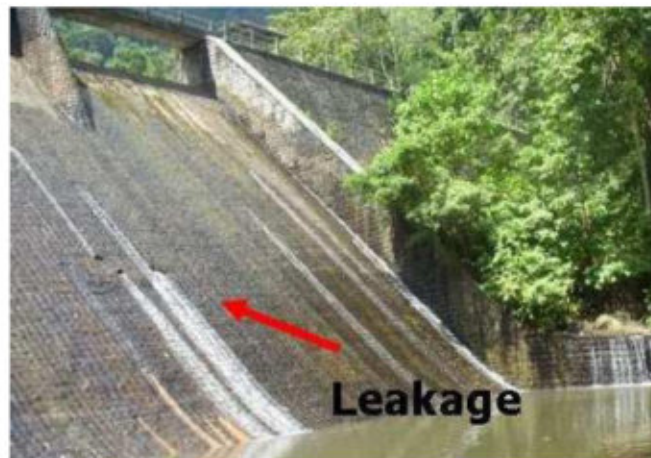
Figure 8. Leakage underneath spillway crest (Courtesy of BWS NT I)

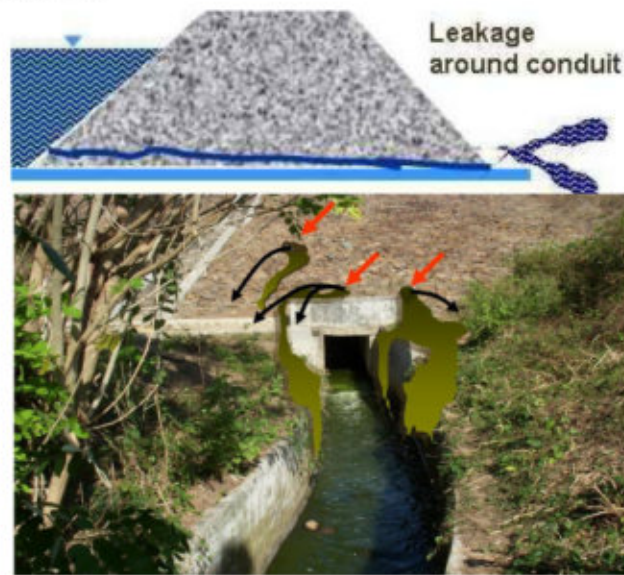
There are conditions where seepages and leakages take place at joint such those along the conduit and other types of outlet works (Figure 9) and between embankment and the wing wall of spillway (Figures 10 and 11). Continuous section of conduit is

prone to cracking although the longitudinal reinforcement continuous through the conduit is already applied.

Figure 9. Seepage and leakage around the outlet structure (Courtesy of BWS NT I)

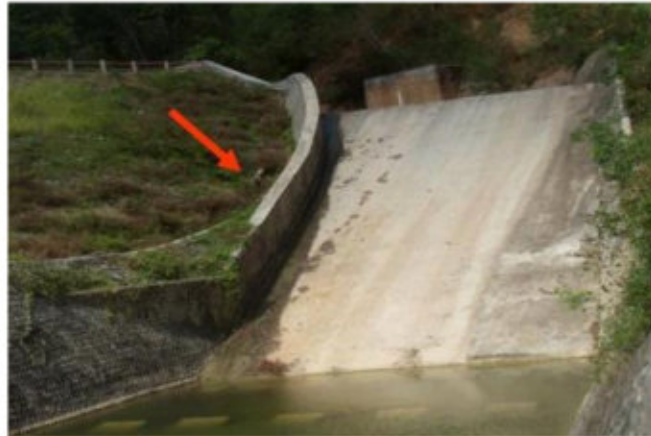
In embung case, leakage between embankment and masonry or concrete structure is normally occurs as a result of different settlement and the existence of other factor such as earthquake. Therefore, sufficient flexibility should be considered to tolerate small settlement as well as the amount of steel reinforcing which should meet the generally accepted requirement.

Figure 10. Leakage between embankment and spillway (Courtesy of BWS NT I)

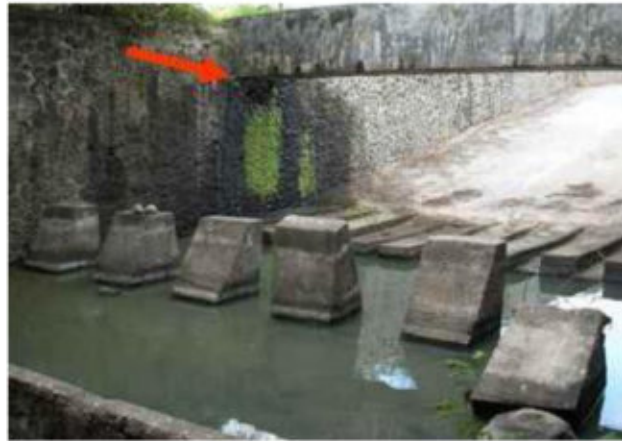
Figure 11. Leakage at the vertical wing wall of stilling basin (Courtesy of BWS NT I)

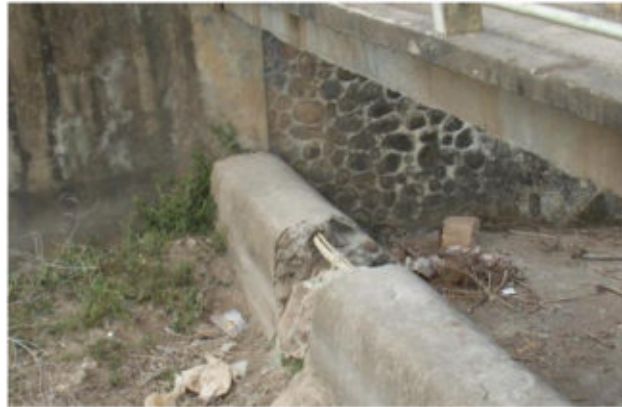
Other problem face by embung is the decrease in the level of service such as damages to the spillway crest (Figure 12), malfunction of outlet work due to improper installation of valve (Figure 13) and disintegration of concrete (Figure 14).

Figure 12. Damages to the spillway crest (Courtesy of BWS NT I)

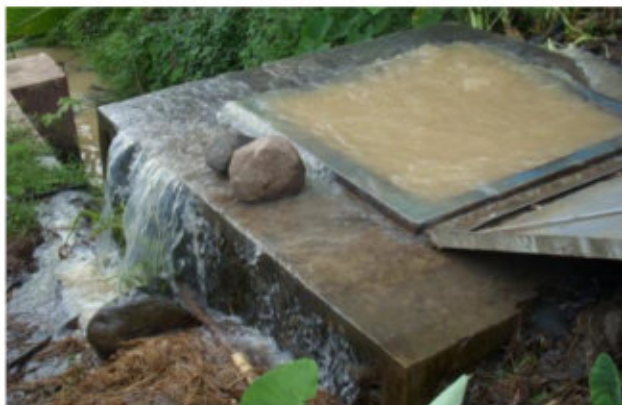
Figure 13. Improper installation of outlet valve (Courtesy of BWS NT I)

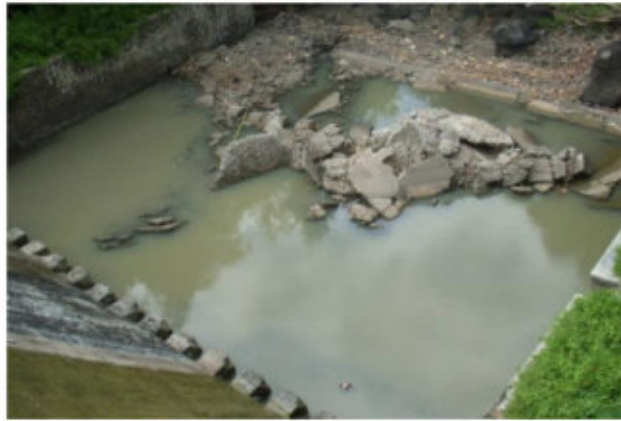
Figure 14. Disintegration of concrete at stilling basin (Courtesy of BWS NT I)

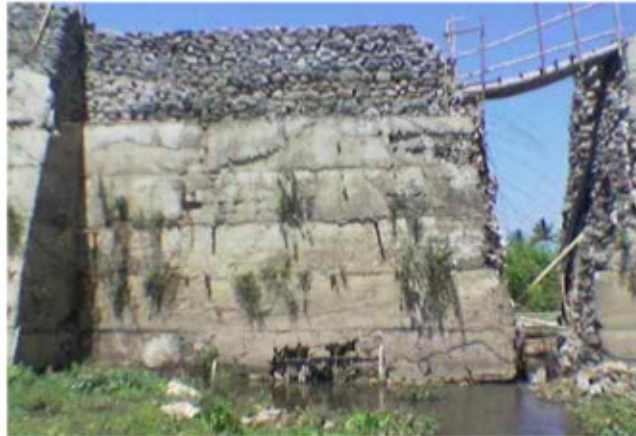
The construction of embung often found to be different than the original design. This inconsistency caused by the temptation to increase the capacity and the level of service. The easiest way is to raise the embankment without due consideration such as the relation of the resulting increased pressures to the limitations of the initial design. In the case of *embung rakyat*, such action may not have dangerous consequences but for a bigger construction of *embung desa* and *embung pemerintah*, structural modification should be made with approval of a qualified engineer, preferably the designer (USBR, 1987). Figure 15 shows an attempt to raise the height of embankment that leads to the failure of embung.

Figure 15. Additional height with different materials (Courtesy of BWS NT I)
